Historical aerial photographs trace the urbanisation of the Moreleta Spruit catchment of Roodeplaas Dam

M J Silberbauer – SASAQS June 2014 – SilberbauerM@dwa.gov.za

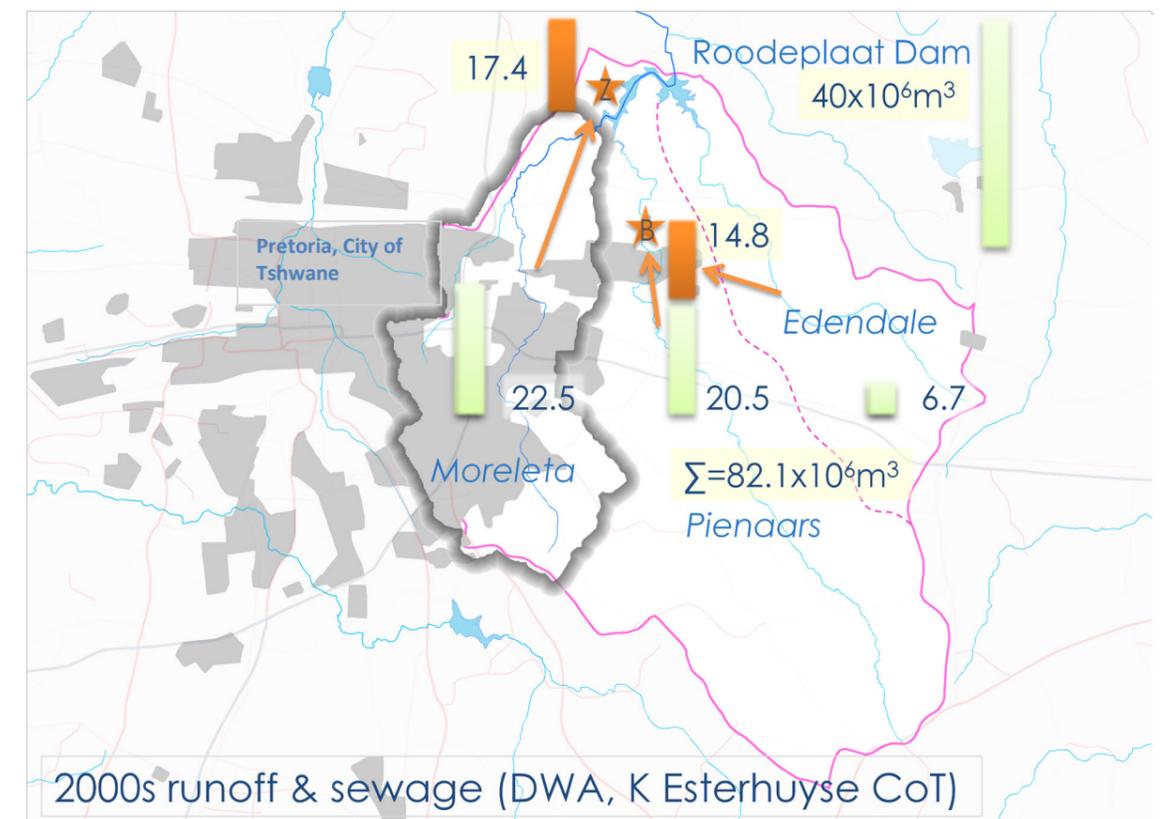
The inflow to Roodeplaas Dam is complex, and this diagram shows a simplified picture. The annual inflow of treated effluent from Zeekoegat (Z) and Baviaanspoort (B) makes up as much as three-quarters of the full supply volume of the dam. Horizontal dotted lines show the estimated natural flow. Missing from this diagram are inflows of water from other catchments. Please consult the original sources for detailed data.

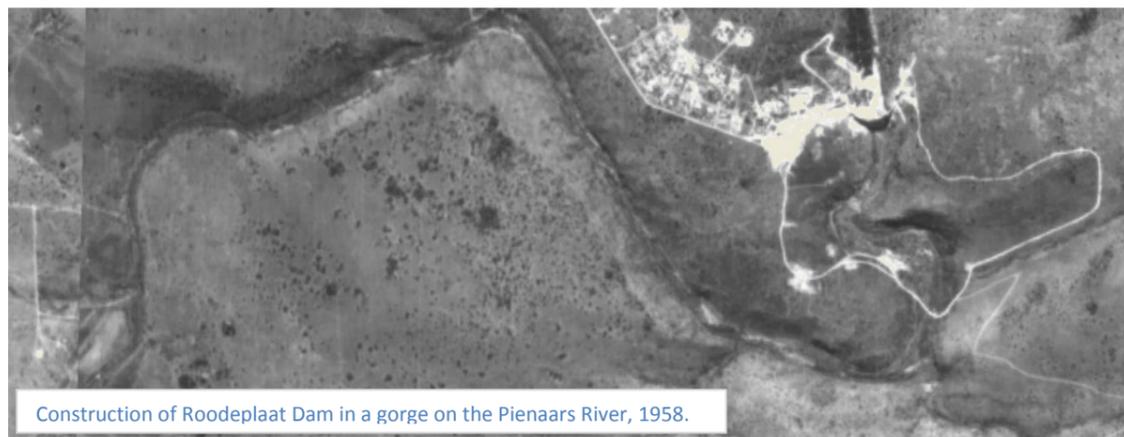
Historical aerial photographs are a valuable source of information—a worthwhile project would be to merge them into continuous, high-quality digital overlays for general use in spatial applications. They are almost always in stereographic pairs, so the opportunity for recreating landscapes in 3D also exists.

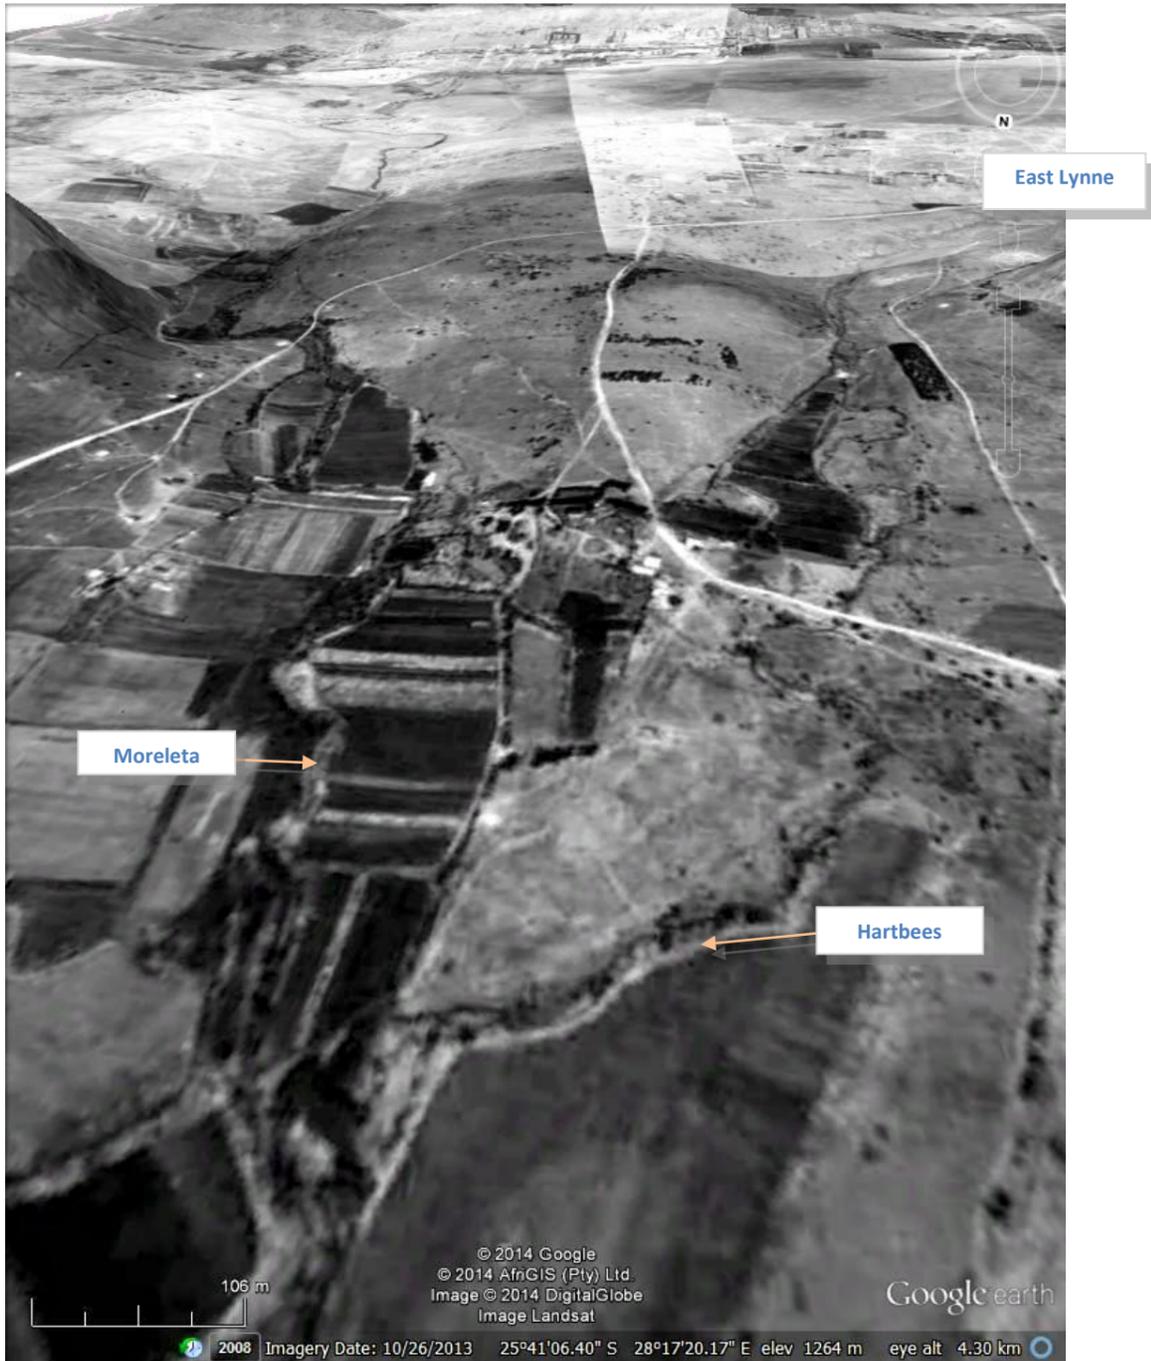
Moreleta and Hartbees catchment at Derdepoort, from 1939 aerial photography provided by AOC through NGI.

<!-- Once the assembled images are georeferenced, overlaying them in a GIS
or Google Earth is fairly simple, as in this KML code snippet -->
<GroundOverlay>
  <name>moreleta_1939_geo_600dpi</name>
  <visibility>0</visibility>
  <description>Aerial photo moreleta_1939_geo_600dpi</description>
  <Icon>
    <href>c:/data_large/photos/2013/map/moreleta_1939_geo_600dpi.jpg</href>
    <viewBoundScale>1</viewBoundScale>
  </Icon>
</GroundOverlay>

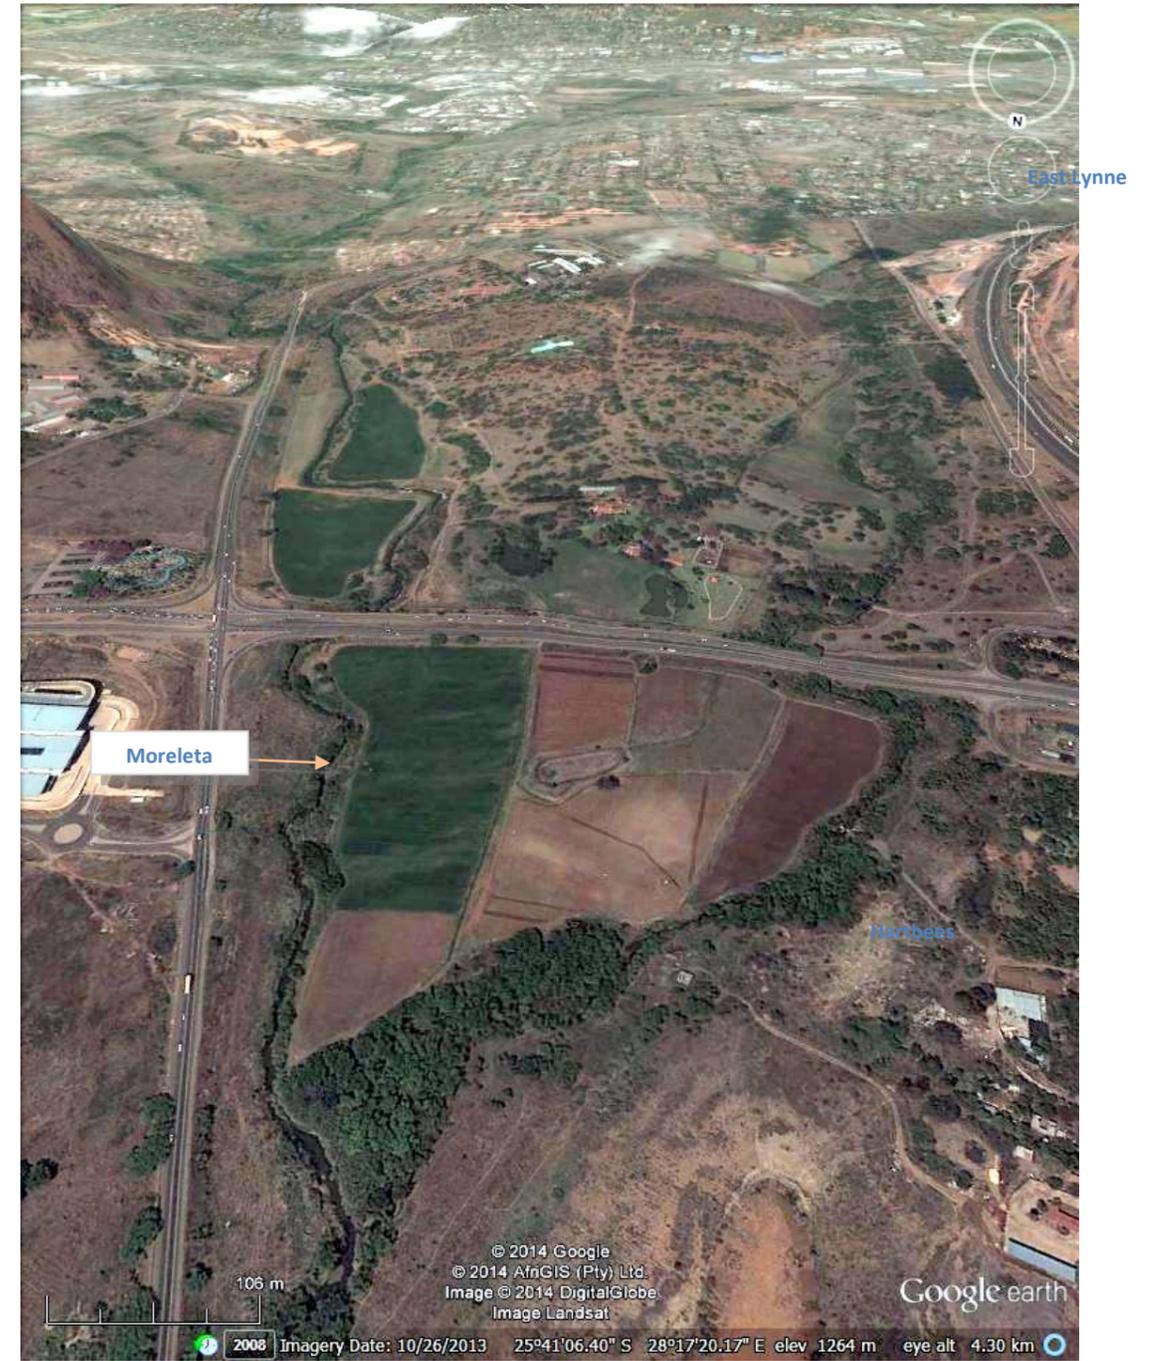
Moreleta and Hartbees catchment at Derdepoort, from 2014 images provided by AfrGIS through Google. Despite protection of a narrow riparian zone, invertebrate habitat assessments show that both rivers are in a poor state (C Todd, personal communication).

<!-- KML continued from box on the left-->
  <LatLonBox>
    <north> -25.6578899 </north>
    <south> -25.8560990 </south>
    <west> 28.2279340 </west>
    <east> 28.3566629 </east>
    <rotation>0</rotation>
  </LatLonBox>
</GroundOverlay>
